Maryland Inventory of Historic Properties
Historic Bridge Inventory
Maryland State Highway Administration
Maryland Historical Trust

MHT Number BA-2866

SHA Bridge No. 3091 Name: MD 147 over Haystack Branch

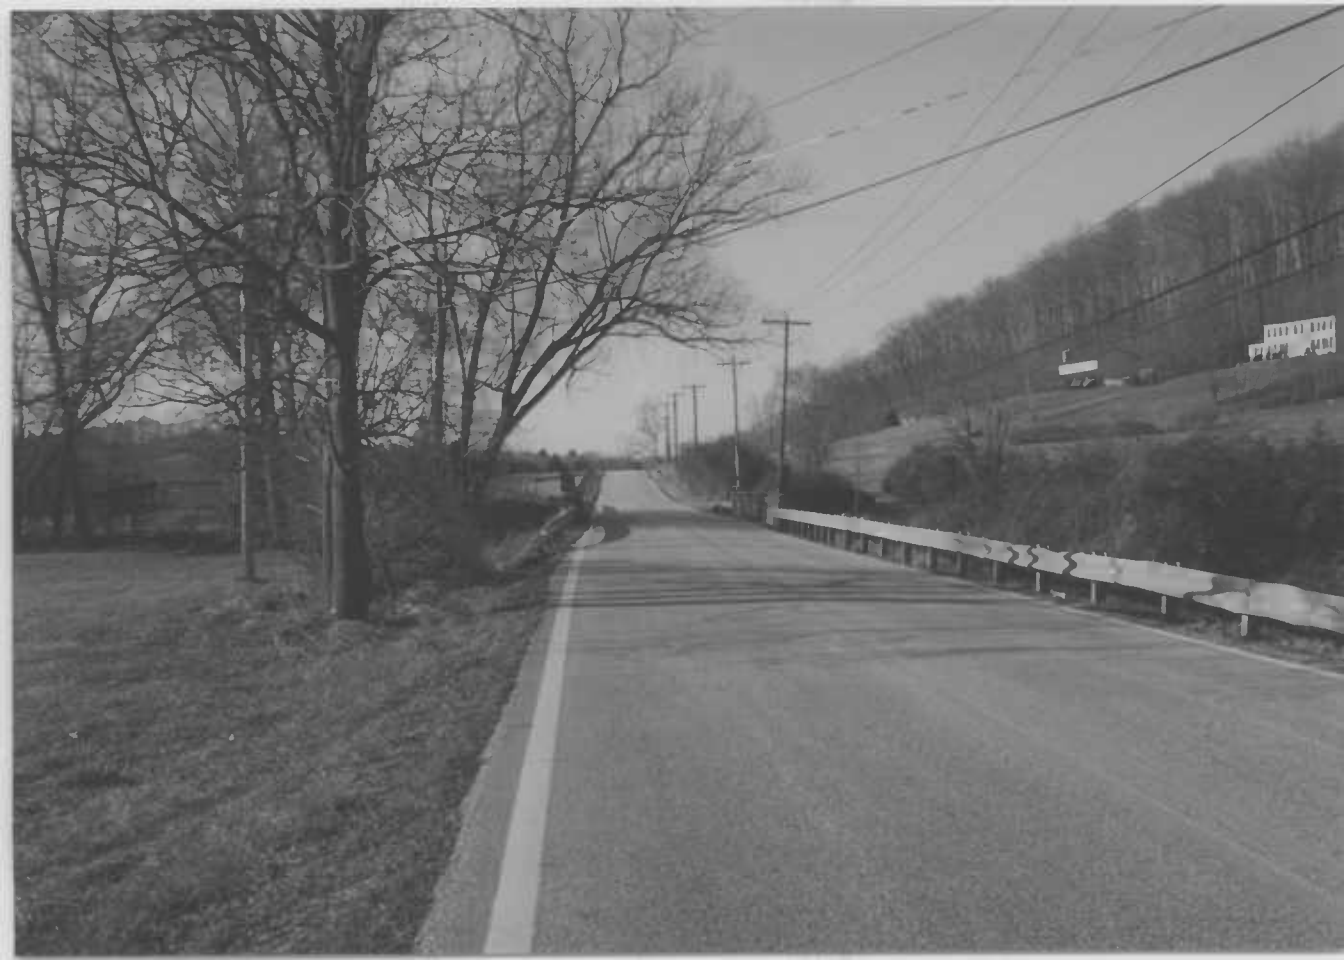
Number # 1 of 4

Description NORTH APPROACH LOOKING
SOUTH

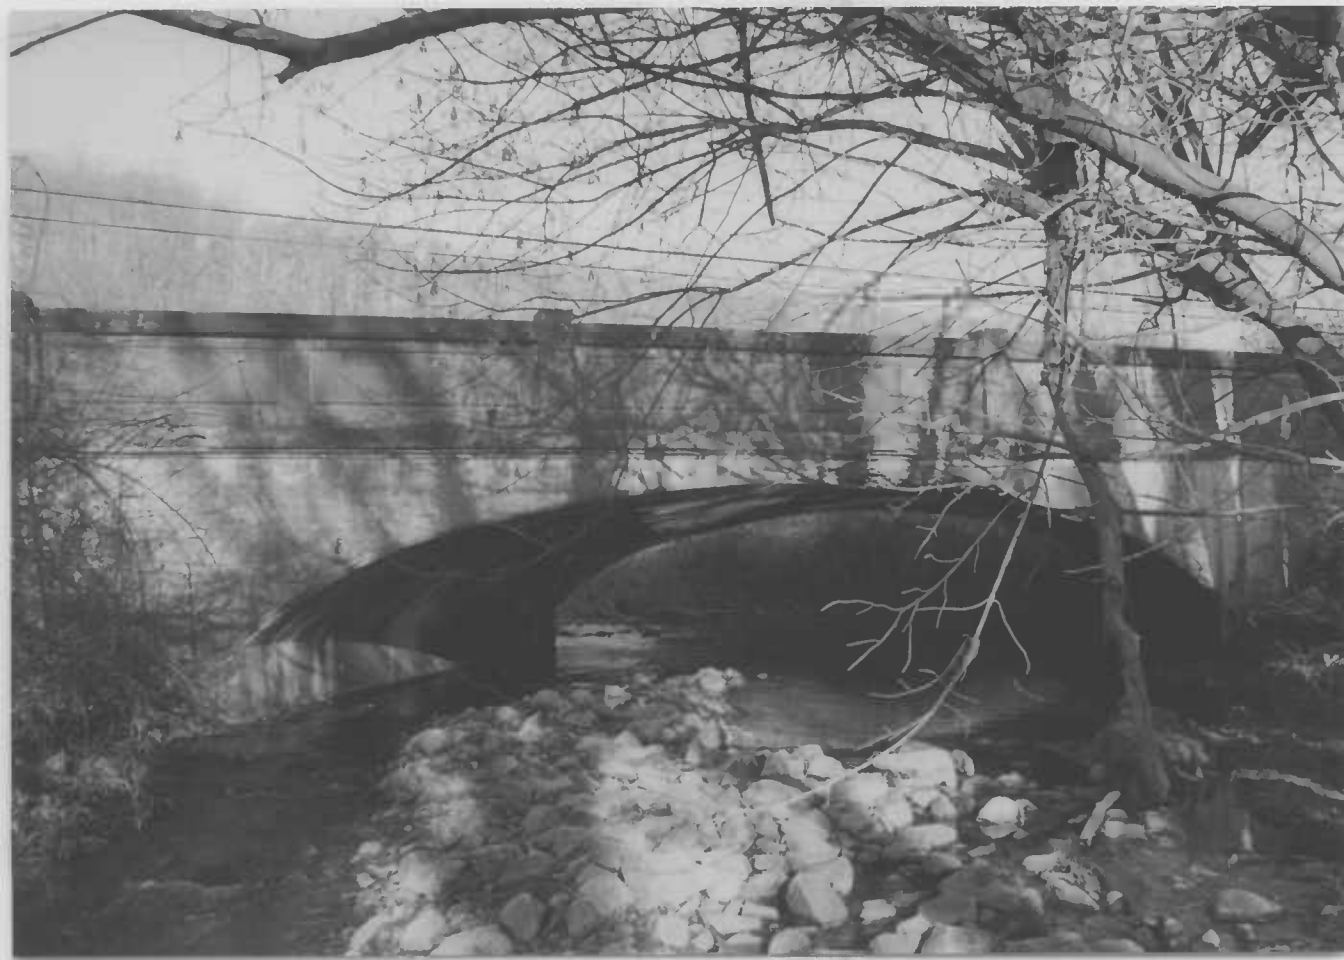
Number # 2 of 4

Description EAST ELEVATION LOOKING
WEST

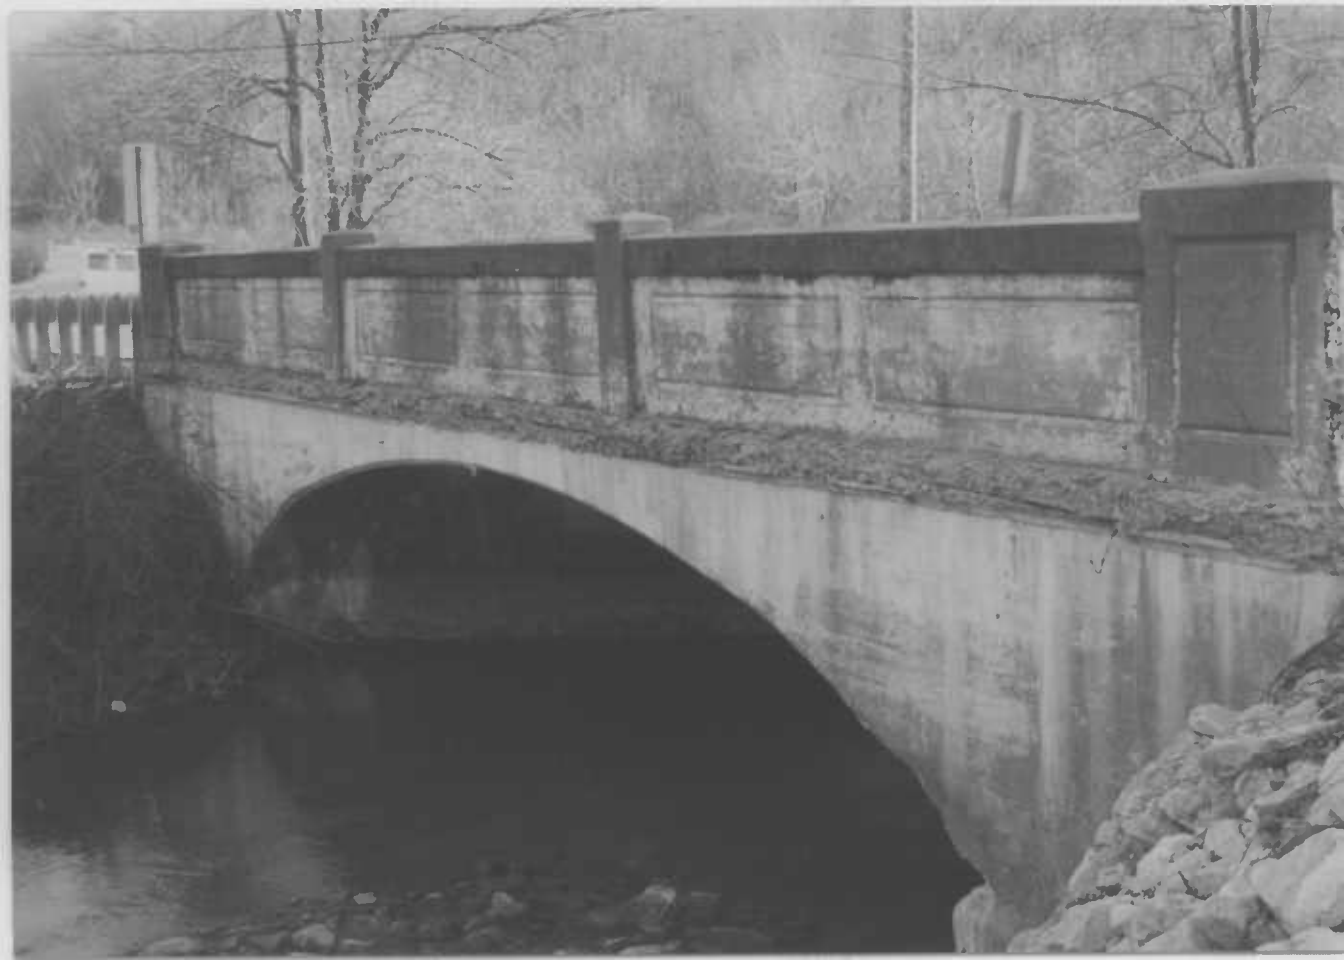
3 OF 4

Description WEST ELEVATION LOOKING

NORTHEAST

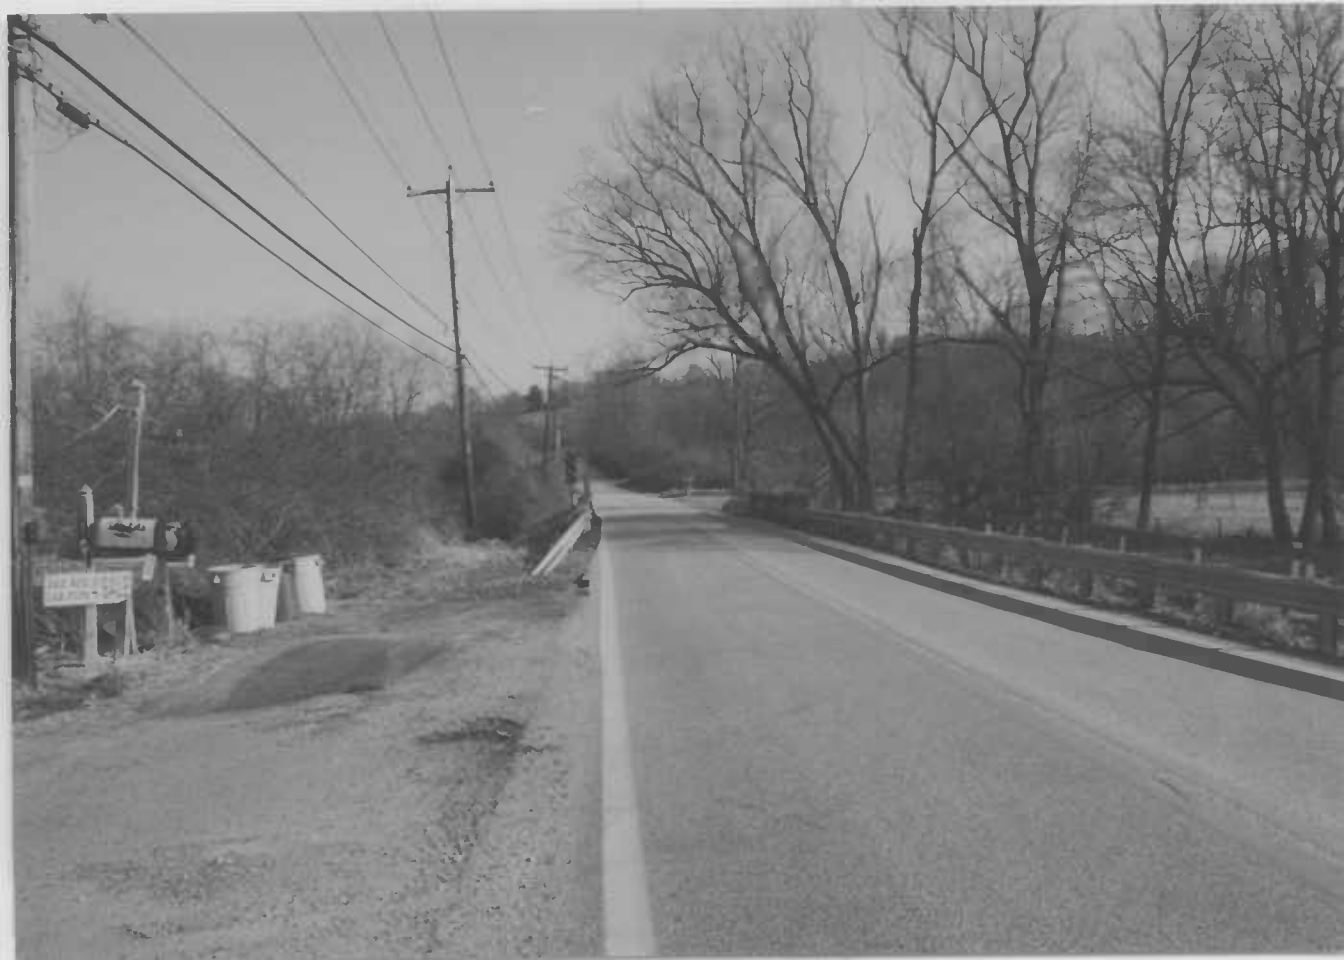
4 OF 4

Description SOUTH APPROACH LOOKING
NORTH
